REQUEST FOR COMMISSION ACTION
CITY OF INDEPENDENCE
April 23, 2020

AGENDA ITEM Consider Change Orders 1, 2, 4, 6, and 7 regarding the 1916 City Hall project.

Re: Independence City Hall – Phase 1 – Change Order No. 1

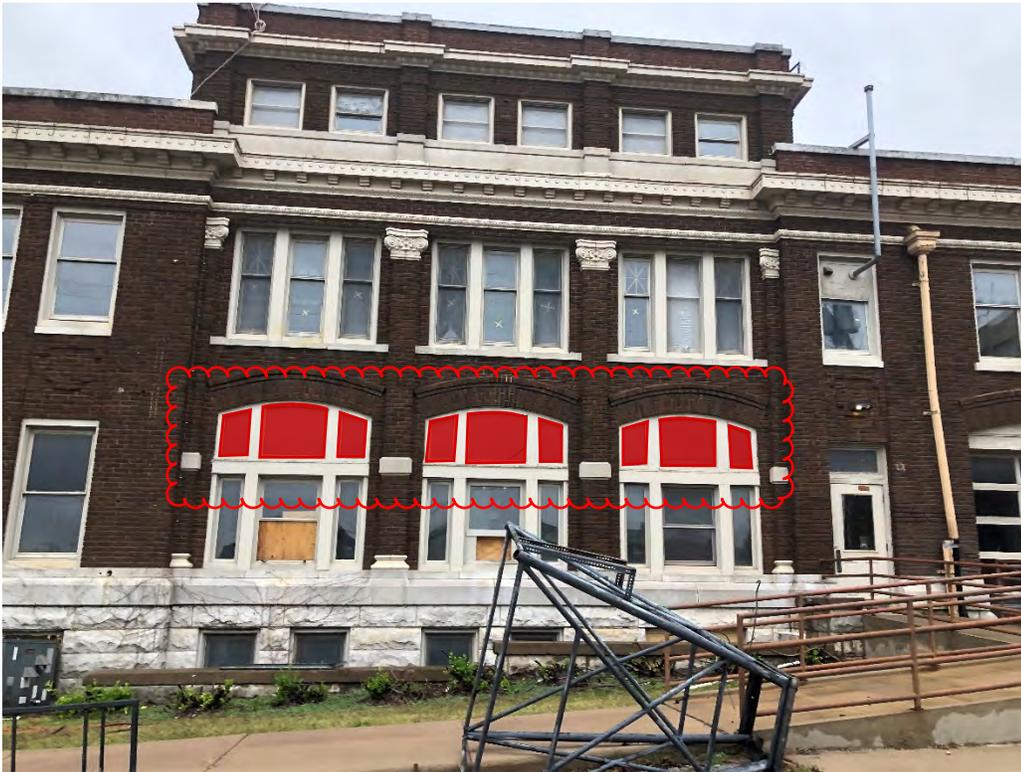
Photo 1: 1st Floor East Elevation – Window Types F & G.

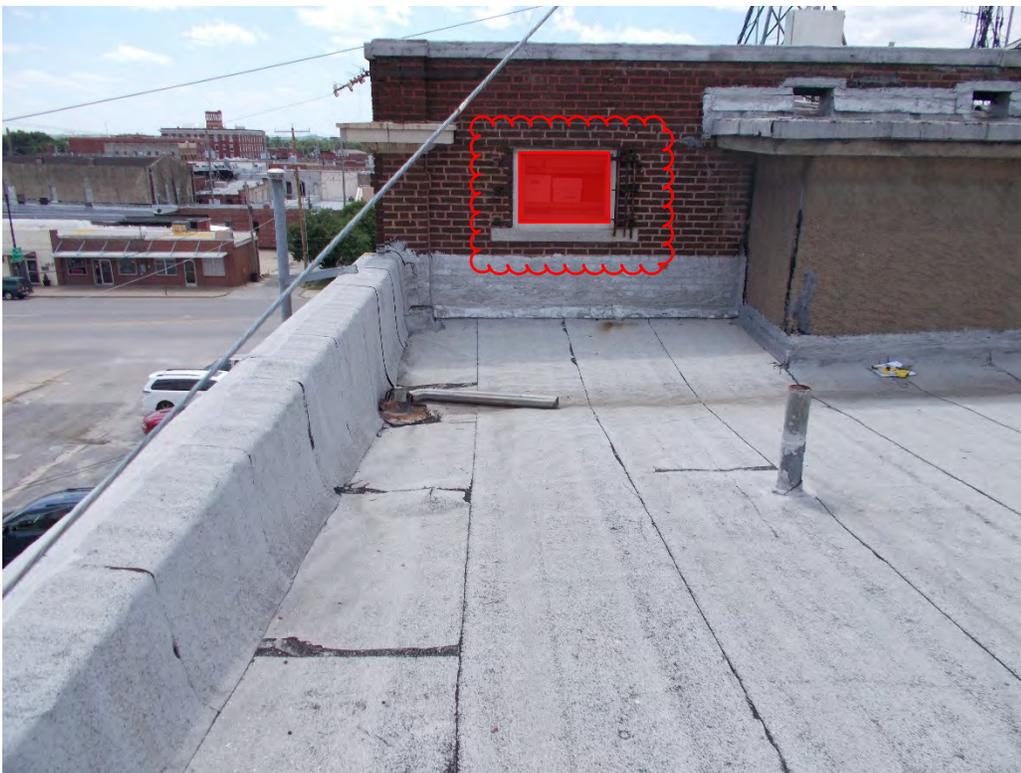
Photo 2: 3rd Floor East Elevation – Window Type C.

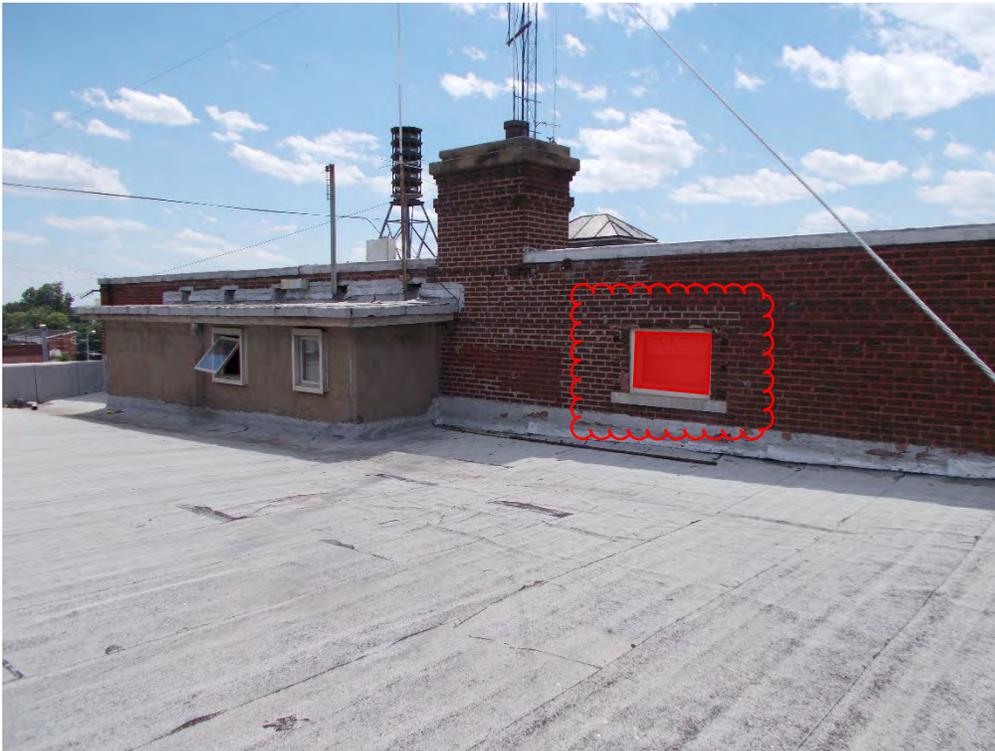
Photo 3: 3rd Floor East Elevation – Window Type C.

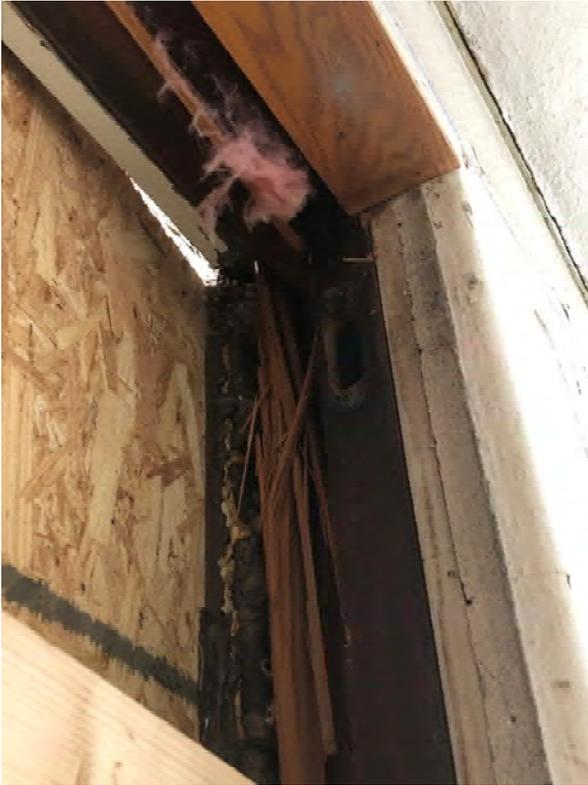
As discussed at the monthly OAC meeting on 2/27/2020, the contractor discovered unforeseen conditions at the window frames during the removal of the existing windows for development of shop drawings. It was discovered that the historic wood window jambs and weight pockets were not fully intact as had been presumed. Based on limited investigation, the contractor has found that many of the wood jambs had previously been roughly cut and or removed in order to utilize metal clips to mount the existing windows to the remaining wood frame components. On these windows there is insufficient wood remaining to provide mounting of the new replacement windows. In addition to this, a number of basement windows, where the historic wood frames remain in place, have extensive deterioration due to moisture or termite damage.

Photo 1: 2nd Floor Window, demonstrating typical condition at 1st & 2nd Floor rough/incomplete previous removal of wood jamb.

Therefore, we have worked with the contractor to develop a process for completing the required work to provide adequate blocking for the installation of the new windows on a Time & Material basis. This will allow the investigation, blocking repair and window installation work to move forward while ensuring both the City and the Contractor are treated fairly.

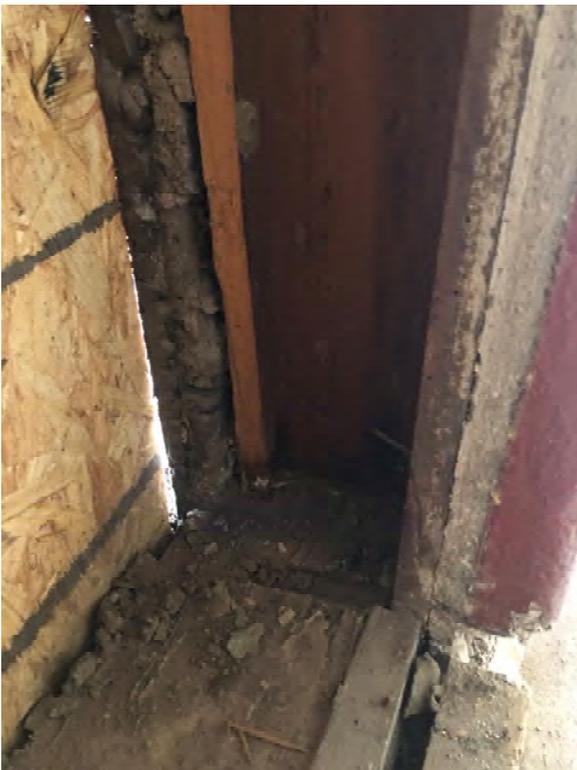
Photo 2: 2nd Floor Window, demonstrating typical condition at 1st & 2nd Floor windows with previously removed wood jamb components.

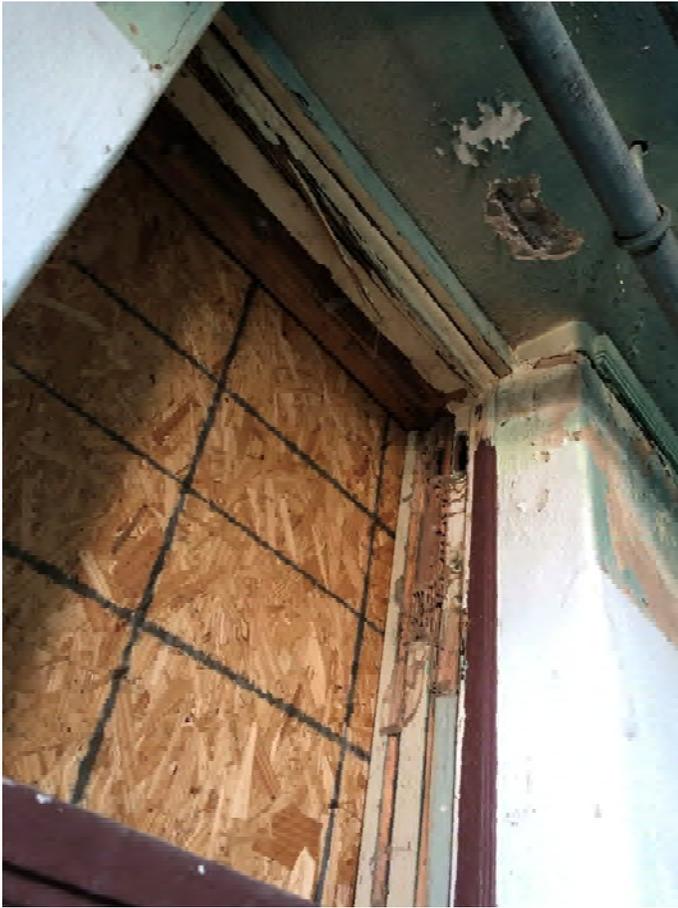
Photo 2: Basement Window, demonstrating typical condition of basement windows with extensive termite deterioration at the upper portion of the wood jamb.

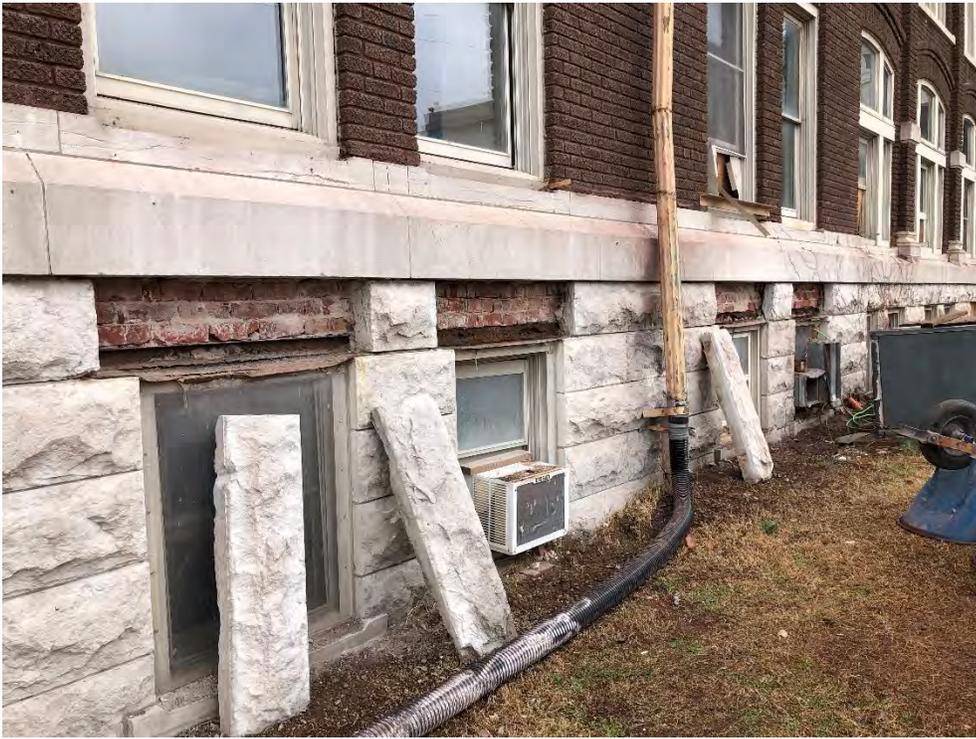
Photo 1: South Elevation – Area of 4 basement window lintels exposed at SW corner.

The four lintels exposed on the west side of the south elevation were found to be badly corroded. The existing steel channel that was initially intended to be left in place displayed full depth corrosion along nearly its entire length. The project mason indicated that he could remove this channel in its entirety except for possibly the very ends on the channel. In that way, a replacement stainless steel lintel of the same size and configuration as the original channel and plate lintel could be installed. Therefore, it was agreed that all of the horizontal steel plate and channel will be removed where practical and where it is not some remnants may remain provided the following conditions are met;

- 1) The existing steel channel is removed to the extent necessary to maintain at least 6" of bearing on the jambs each end.
- 2) No portion of the steel plate that is proud of the channel will be left in place so as to eliminate the potential for future rust jacking of the plate and associated damage to the stone at the bed joints.

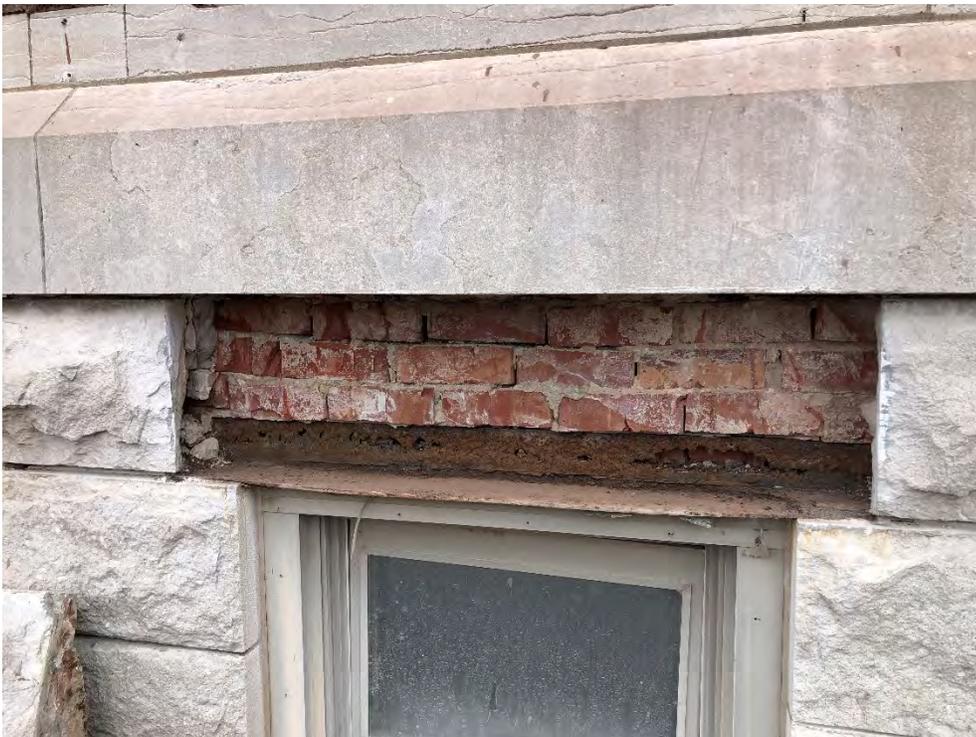
As we had discussed at the monthly OAC meeting on 2/27/2020, the masons discovered unforeseen conditions at the basement window steel lintels during the removal of the stone lintels for repair work. The work outlined in the construction documents is to remove the stone lintels, allowing the visibly deteriorated steel plate underneath to be removed back flush with the existing steel channel, and a new stainless steel angle inserted to replace the deteriorated plates. The existing historic channels were found on the North and South elevations to be deteriorated, in some cases almost entirely missing, due to past water infiltration into the wall and resulting corrosion. Lintels at the west elevation were found to be in good condition.

The structural engineer has concluded that these historic steel channels with attached steel plates are not fully loadbearing, but if not replaced the possibility remains of inadvertently changing load paths in the wall. This could lead to future maintenance issues with cracking of the stone lintels or displacement/damage to the basement windows.

Photo 2: South Elevation Basement Window Lintel – showing severe deterioration in the steel C-channel and deformation of the steel plate at the base due to expansion of the corroding steel.

Therefore, the mason has proposed removing the deteriorated steel C-channel, removing as much of the corroded steel material as possible from the surrounding masonry joints, and utilizing stainless steel profiles to replace the historic steel channel lintels in kind. The stainless steel angles will then be installed and the stone lintels reset, as originally included in the scope. TreanorHL and the structural engineer have worked with the masons to reduce the proposed cost of this change order from \$62,159.80 to \$24,702.00, via alternative temporary shoring methods during the work.

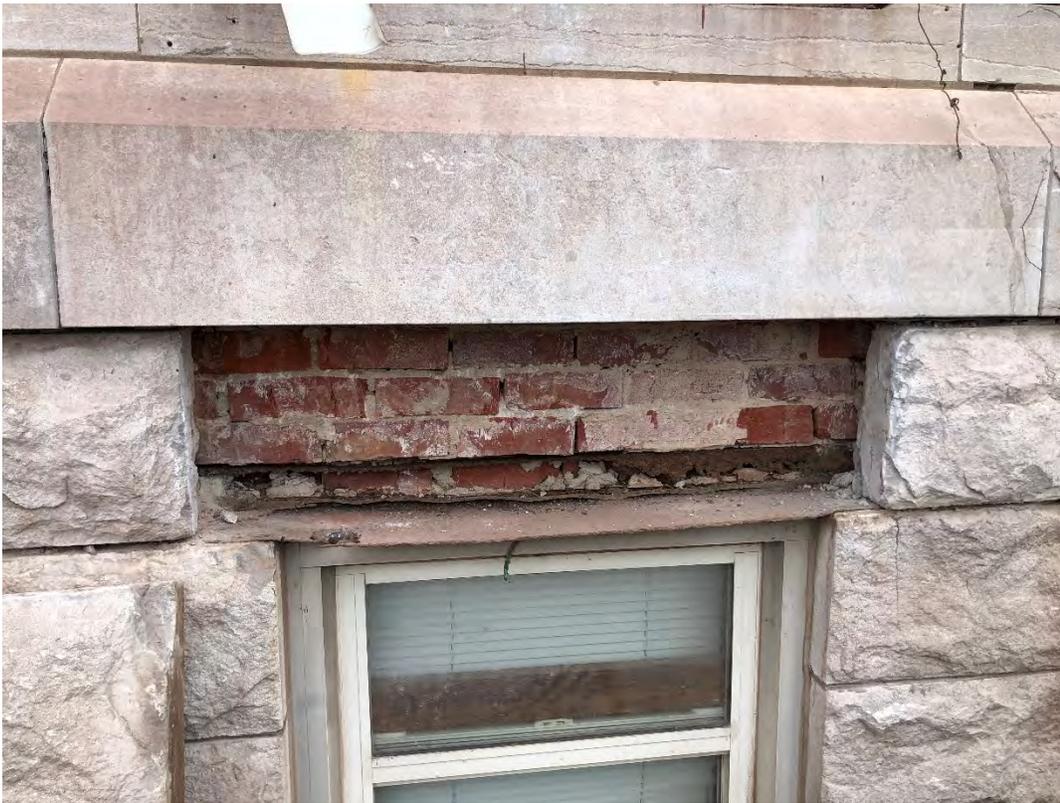
Photo 3: South Elevation Basement Window Lintel – Showing near total loss of the steel C-channel to corrosion, with brick masonry behind clearly visible.

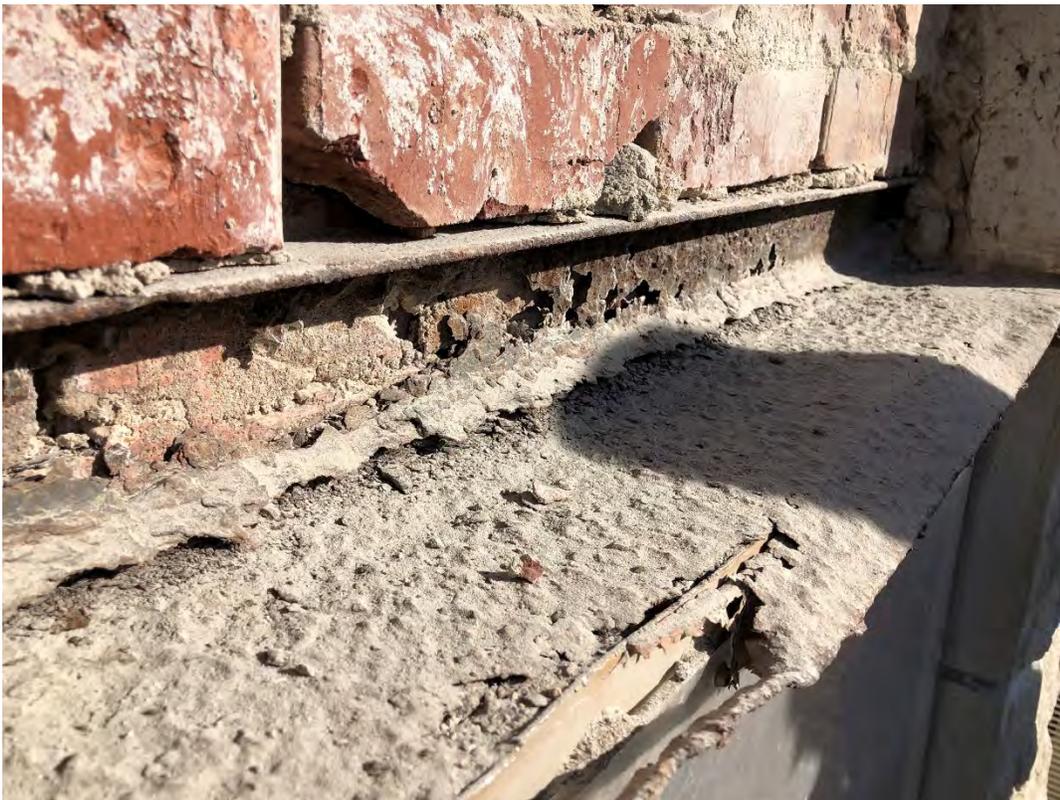
Photo 4: Closeup of adjacent lintel with similar condition to that in Photo 3 above.

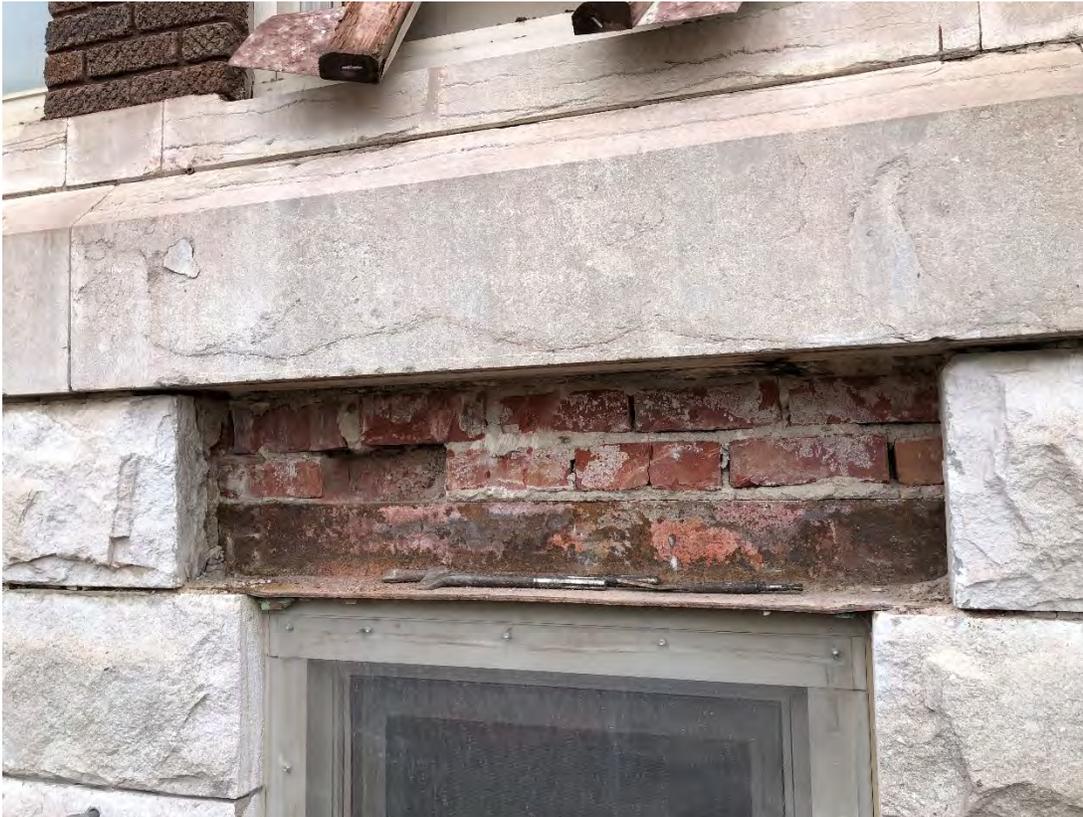
Photo 5: West Elevation Basement Window Lintel – Showing existing historic steel lintel in good condition, typical of all exposed lintels on the west elevation.

The two lintels exposed on the south side of the west elevation were found to be in much better condition. Here the original detail per the contract documents is applicable. That is, all of the steel plate proud of the channel will be removed, the remaining steel channel cleaned and corrosion protected, and a new stainless steel angle installed.

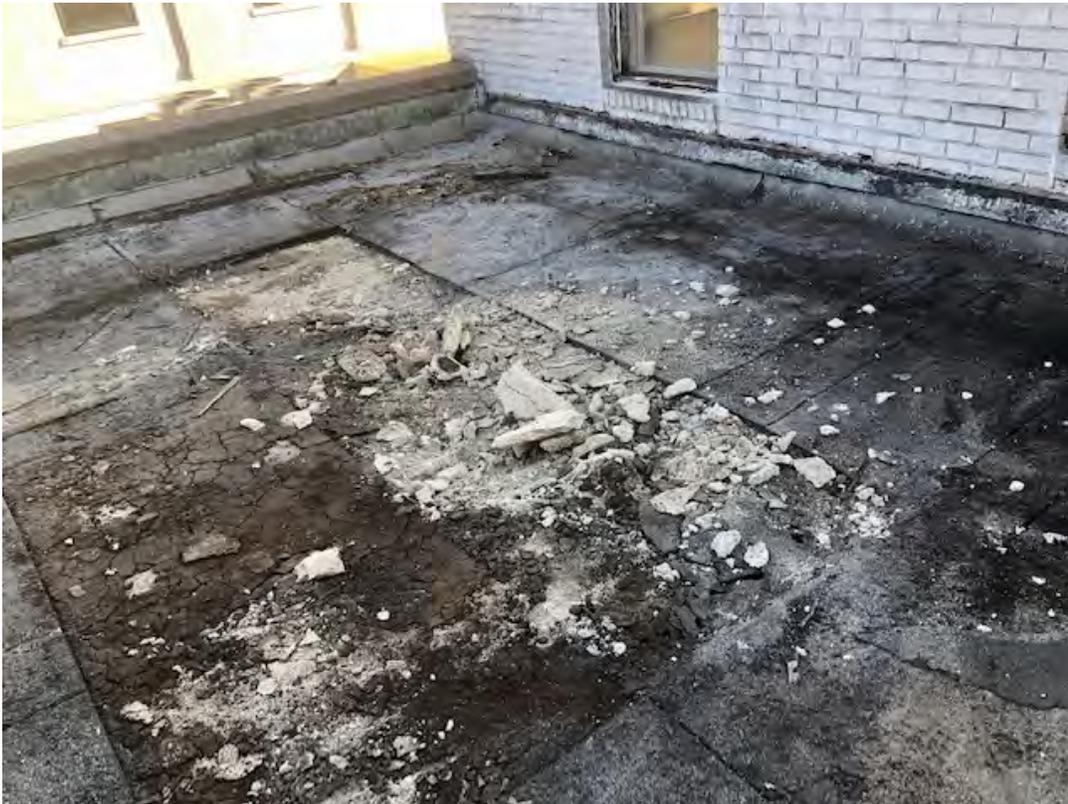
As we had discussed at the monthly OAC meeting on 2/27/2020, the roofer discovered unforeseen conditions at the East apparatus bay addition during the tear-off of the existing roof. The existing roof deck was found to be a poured lightweight concrete or gypsum product over corrugated steel decking. The poured product was found to be brittle, with large areas coming up with the existing roofing. Also present were areas of corrosion and holes at the SW corner, where the addition roof drains into an existing gutter. This prompted a halt to the roofer's work and a site visit from the structural engineer for investigation. Due to the potential additional costs of repairing the roof deck, and the unknown specifics of the future layout of the required addition in the Phase 2 design work, it was decided in consultation with the City that this reroofing work be eliminated from the current scope.

Photo 1: Apparatus Bay Addition Roof – Area of demolition at south, revealing deteriorated gypsum product.

Option 1) Remove all of the existing roofing down to the metal deck. I would then return to the site to inspect the condition of the roof deck and verify its attachment to the bar joists below. I would provide deck repair details if needed. An appropriate lightweight concrete topping would then be applied to the roof deck to match the original construction and then the roofing materials that have already been purchased and are on site would be applied.

Option 2) Remove the existing roofing and inspect and repair the existing deck as per Option 1. The deck could then be roofed with appropriate materials to be applied to the metal deck and the lightweight concrete would not be replaced. This would require purchasing new roofing materials appropriate to this application.

Option 3) Maintain temporary waterproofing on the existing roof deck until such time as the east addition was demolished to make room for a new addition.

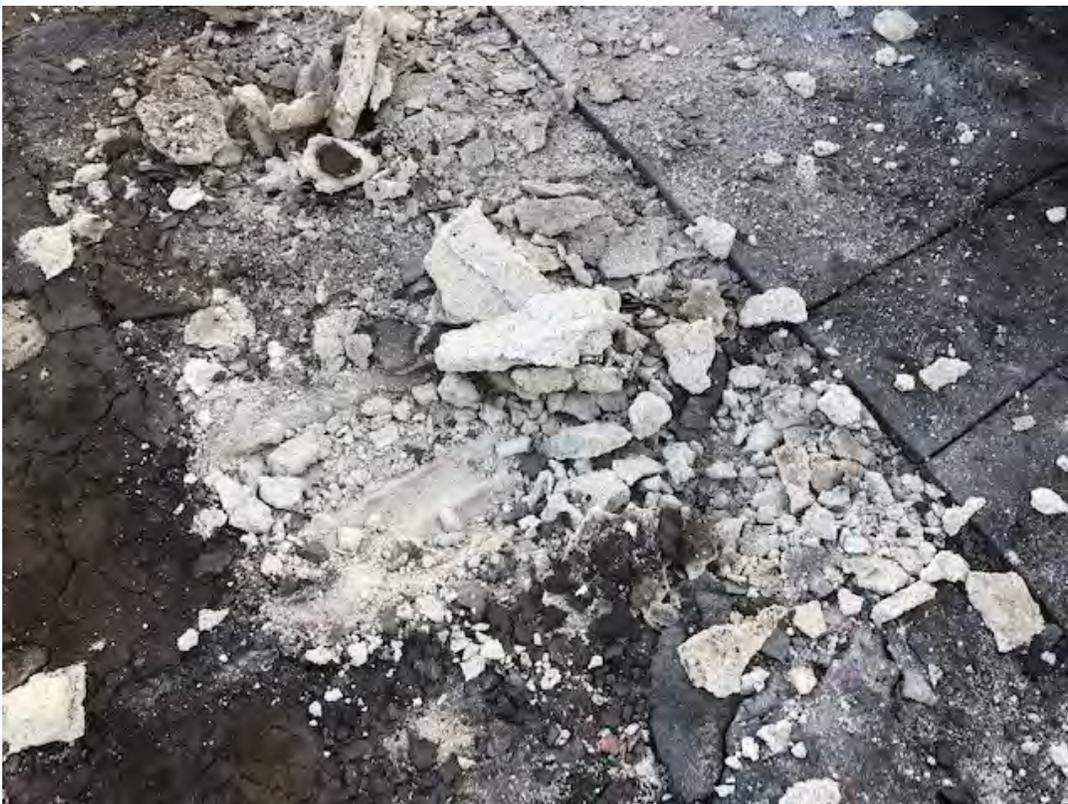
The roof over the east addition consists of 12" deep bar joists spanning east-west at 4'-8" on center with galvanized corrugated roof deck spanning over the joists. The joists are in good condition. The bottom side of the roof deck that was visible was found to be in fair to good condition, with small random areas of damage. While the top side of the roof was not visible during our visit, the contractor reported that the existing lightweight concrete/gypcrete is in very bad condition and the roofer has indicated that it is not suitable to roof to. Therefore, I suggested that the following options exist;

Photo 2: Apparatus Bay Addition Roof – Close up of deteriorated poured deck product.

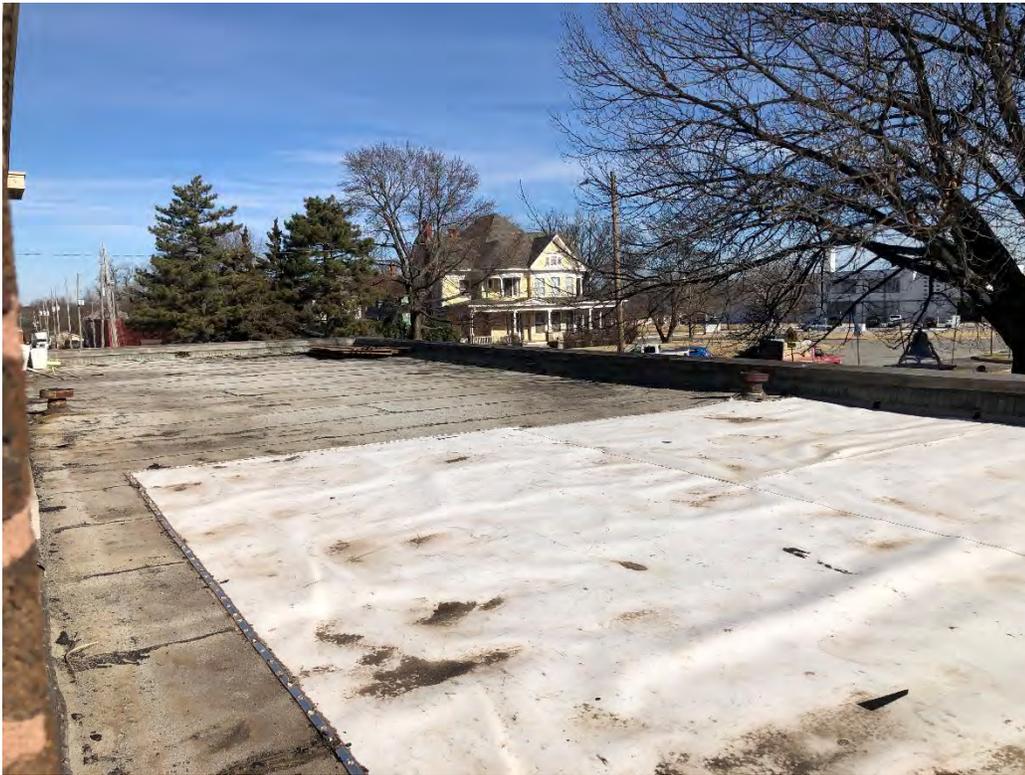
Photo 3: Apparatus Bay Addition Roof – Area of temporary TPO roofing, looking NE.

Therefore, the contractor has proposed a credit for the reroofing work that will not be performed, minus the cost of the temporary TPO roof that was installed over the area that was removed when the issues were discovered. The roofing materials already purchased for this area of the roof will be retained by the City for use on the Phase 2 addition roof, with the intent that the eventual addition roof is a white modified bitumen system to match the main roof.

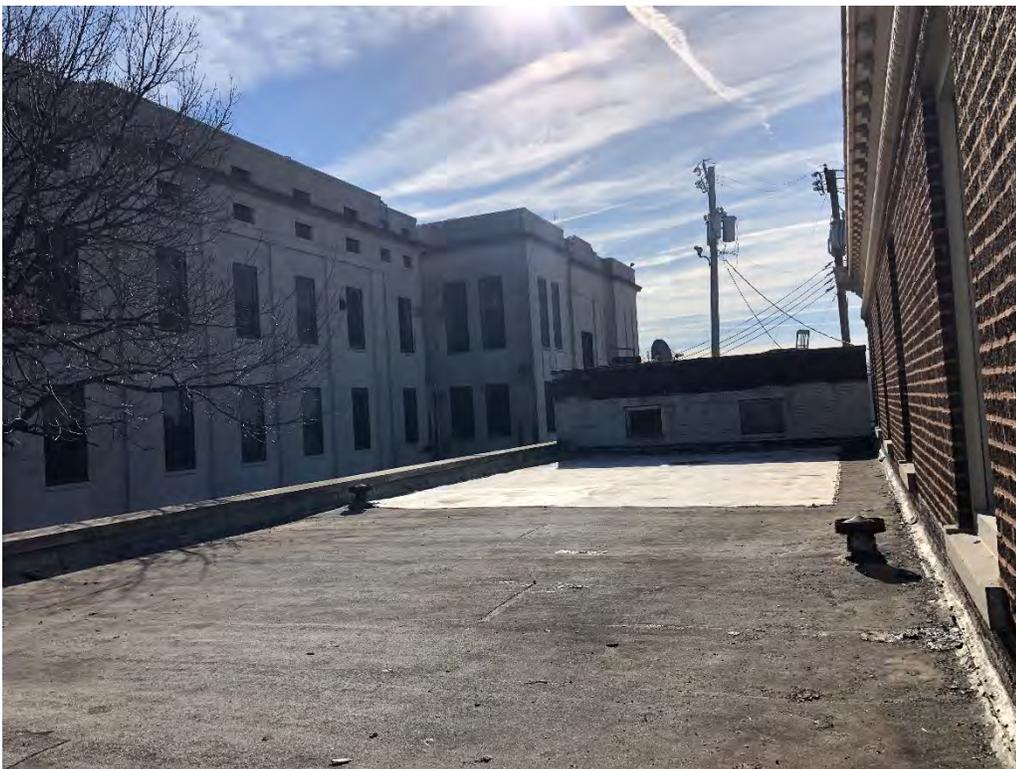
Photo 4: Apparatus Bay Addition Roof – Area of temporary TPO roofing, looking SE.
